**USEPA – Region 4
Superfund Site Inspection Report
Hurricane IRMA Follow-up**

Site: Pickettville Road Landfill

Location (City/State): Jacksonville, Florida

Date of Inspection: 09/14/2017

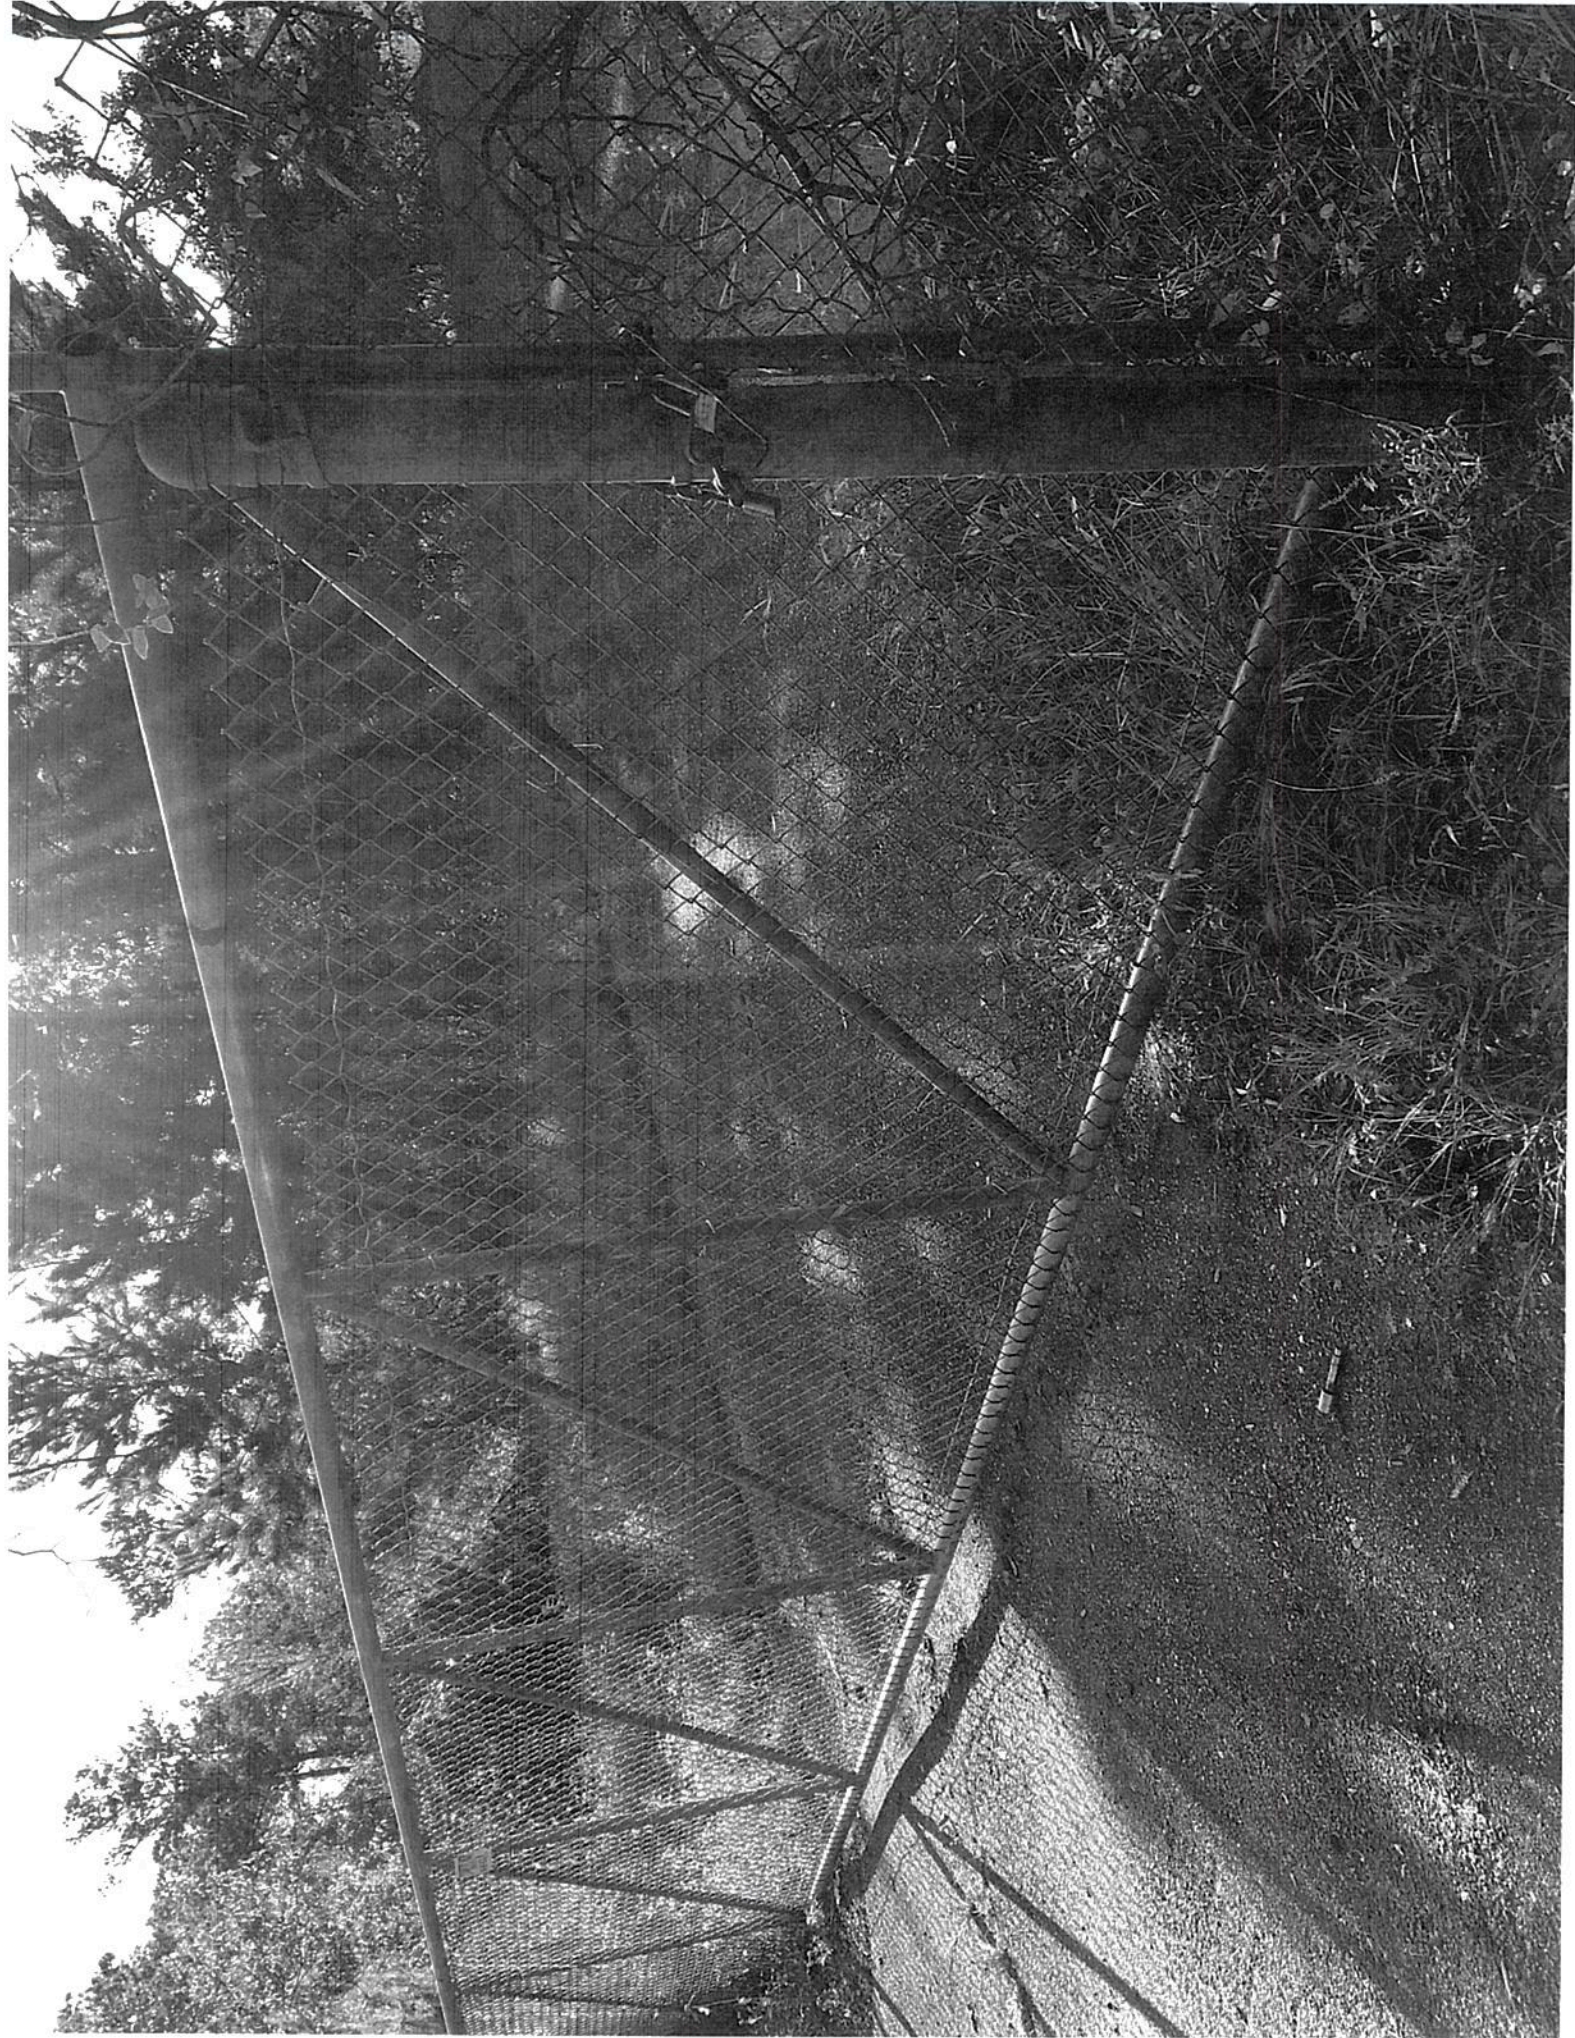
Site Condition: Site is good condition. Debris and falling trees were observed along Pickettville Road.

- **Damaged Equipment: fencing, gates, pumps, piping, etc.:** Falling trees on property and fence along Pickettville Rd. But no substantial damages.
- **Floodwaters:** No standing water observed. But debris was observed along Pickettville Rd.
- **Cover integrity: Cap scouring, erosion:** None observed
- **Monitor well integrity: flooded; missing caps; concrete pads:** None observed

Recommendation for follow up Action: No immediate follow-up required. But falling trees removal and cleanup necessary in the near term.

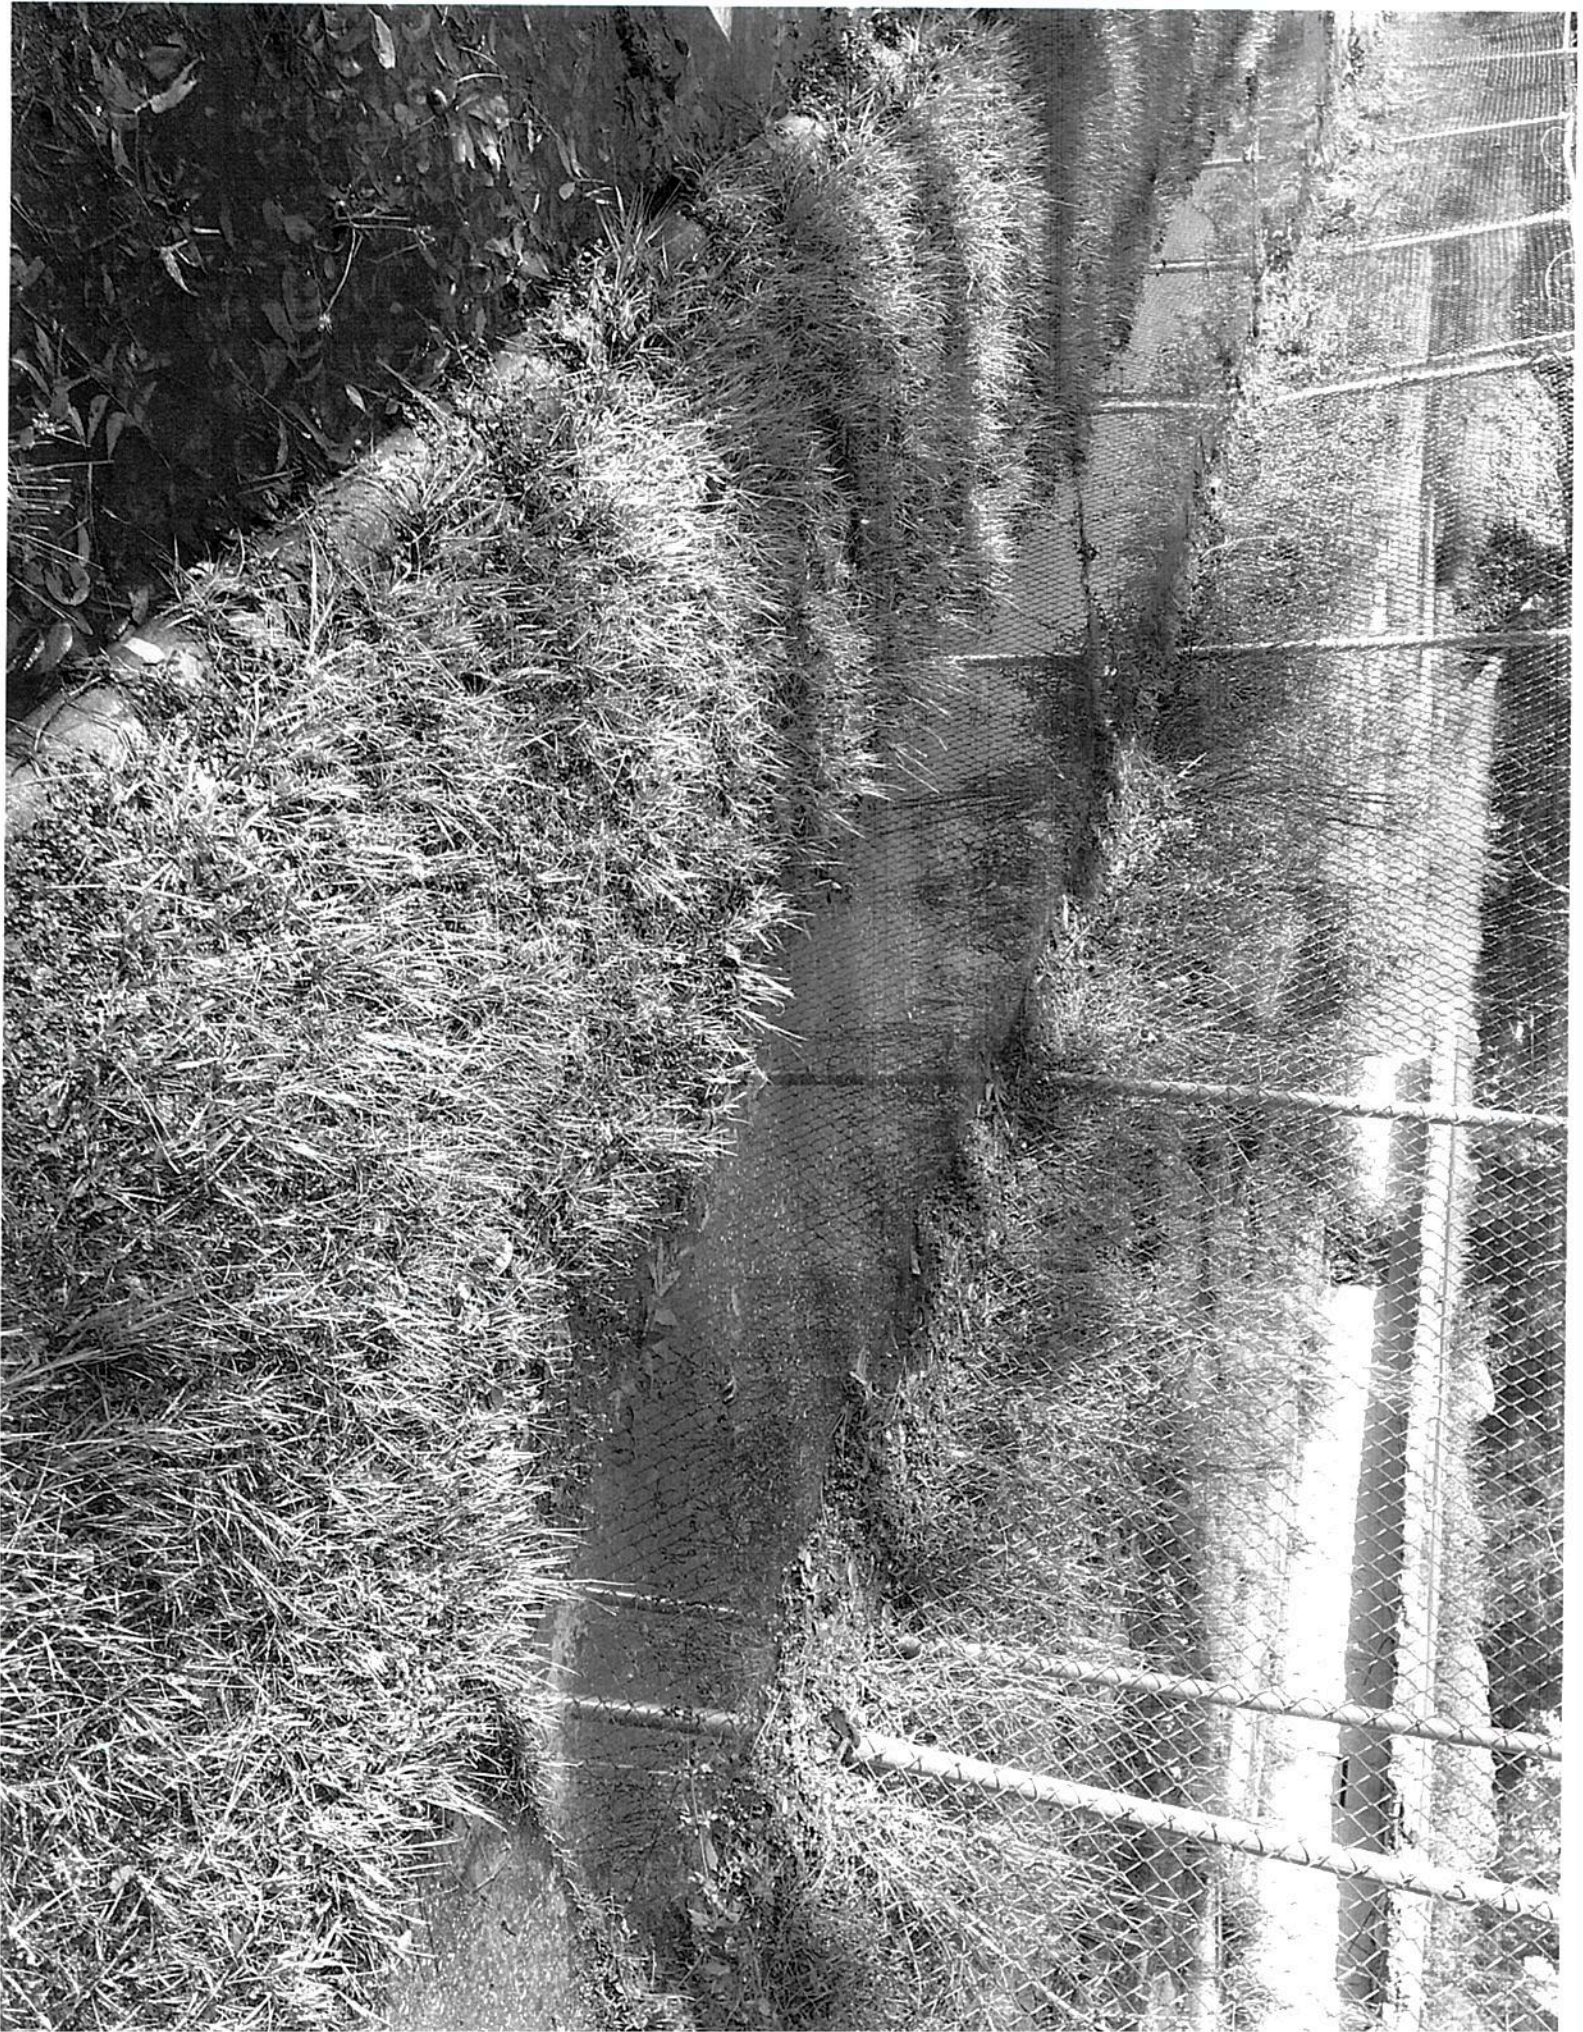
Site Condition: Site is relatively in good condition but follow-up action is necessary.

- **Damaged Equipment: fencing, gates, pumps, piping, etc.:** – Fence damages observed at two main locations (Northwest and southwest corners of property). Southwest damages from falling tree limbs/branches. Northwest damages due to erosion. Loose barbed wire at several areas of fence. Household trash was also observed along the fence on 14th Street.
- **Floodwaters:** Standing water observed along Fairfax Street. Surface water overflow from retention pond was observed. City representative expressed concerns about contaminated water being discharged to nearby creek.
- **Cover integrity: Cap scouring, erosion:** Substantial erosion observed (Northwest corner by railroad tracks)
- **Monitor well integrity: flooded; missing caps; concrete pads.:** None observed

Recommendation for follow up Action: Fence repairs (particularly on the northwest corner of the property near railroad tracks). City representative recommends that surface water sampling be performed to confirm contaminated surface water is not discharged into nearby creek.

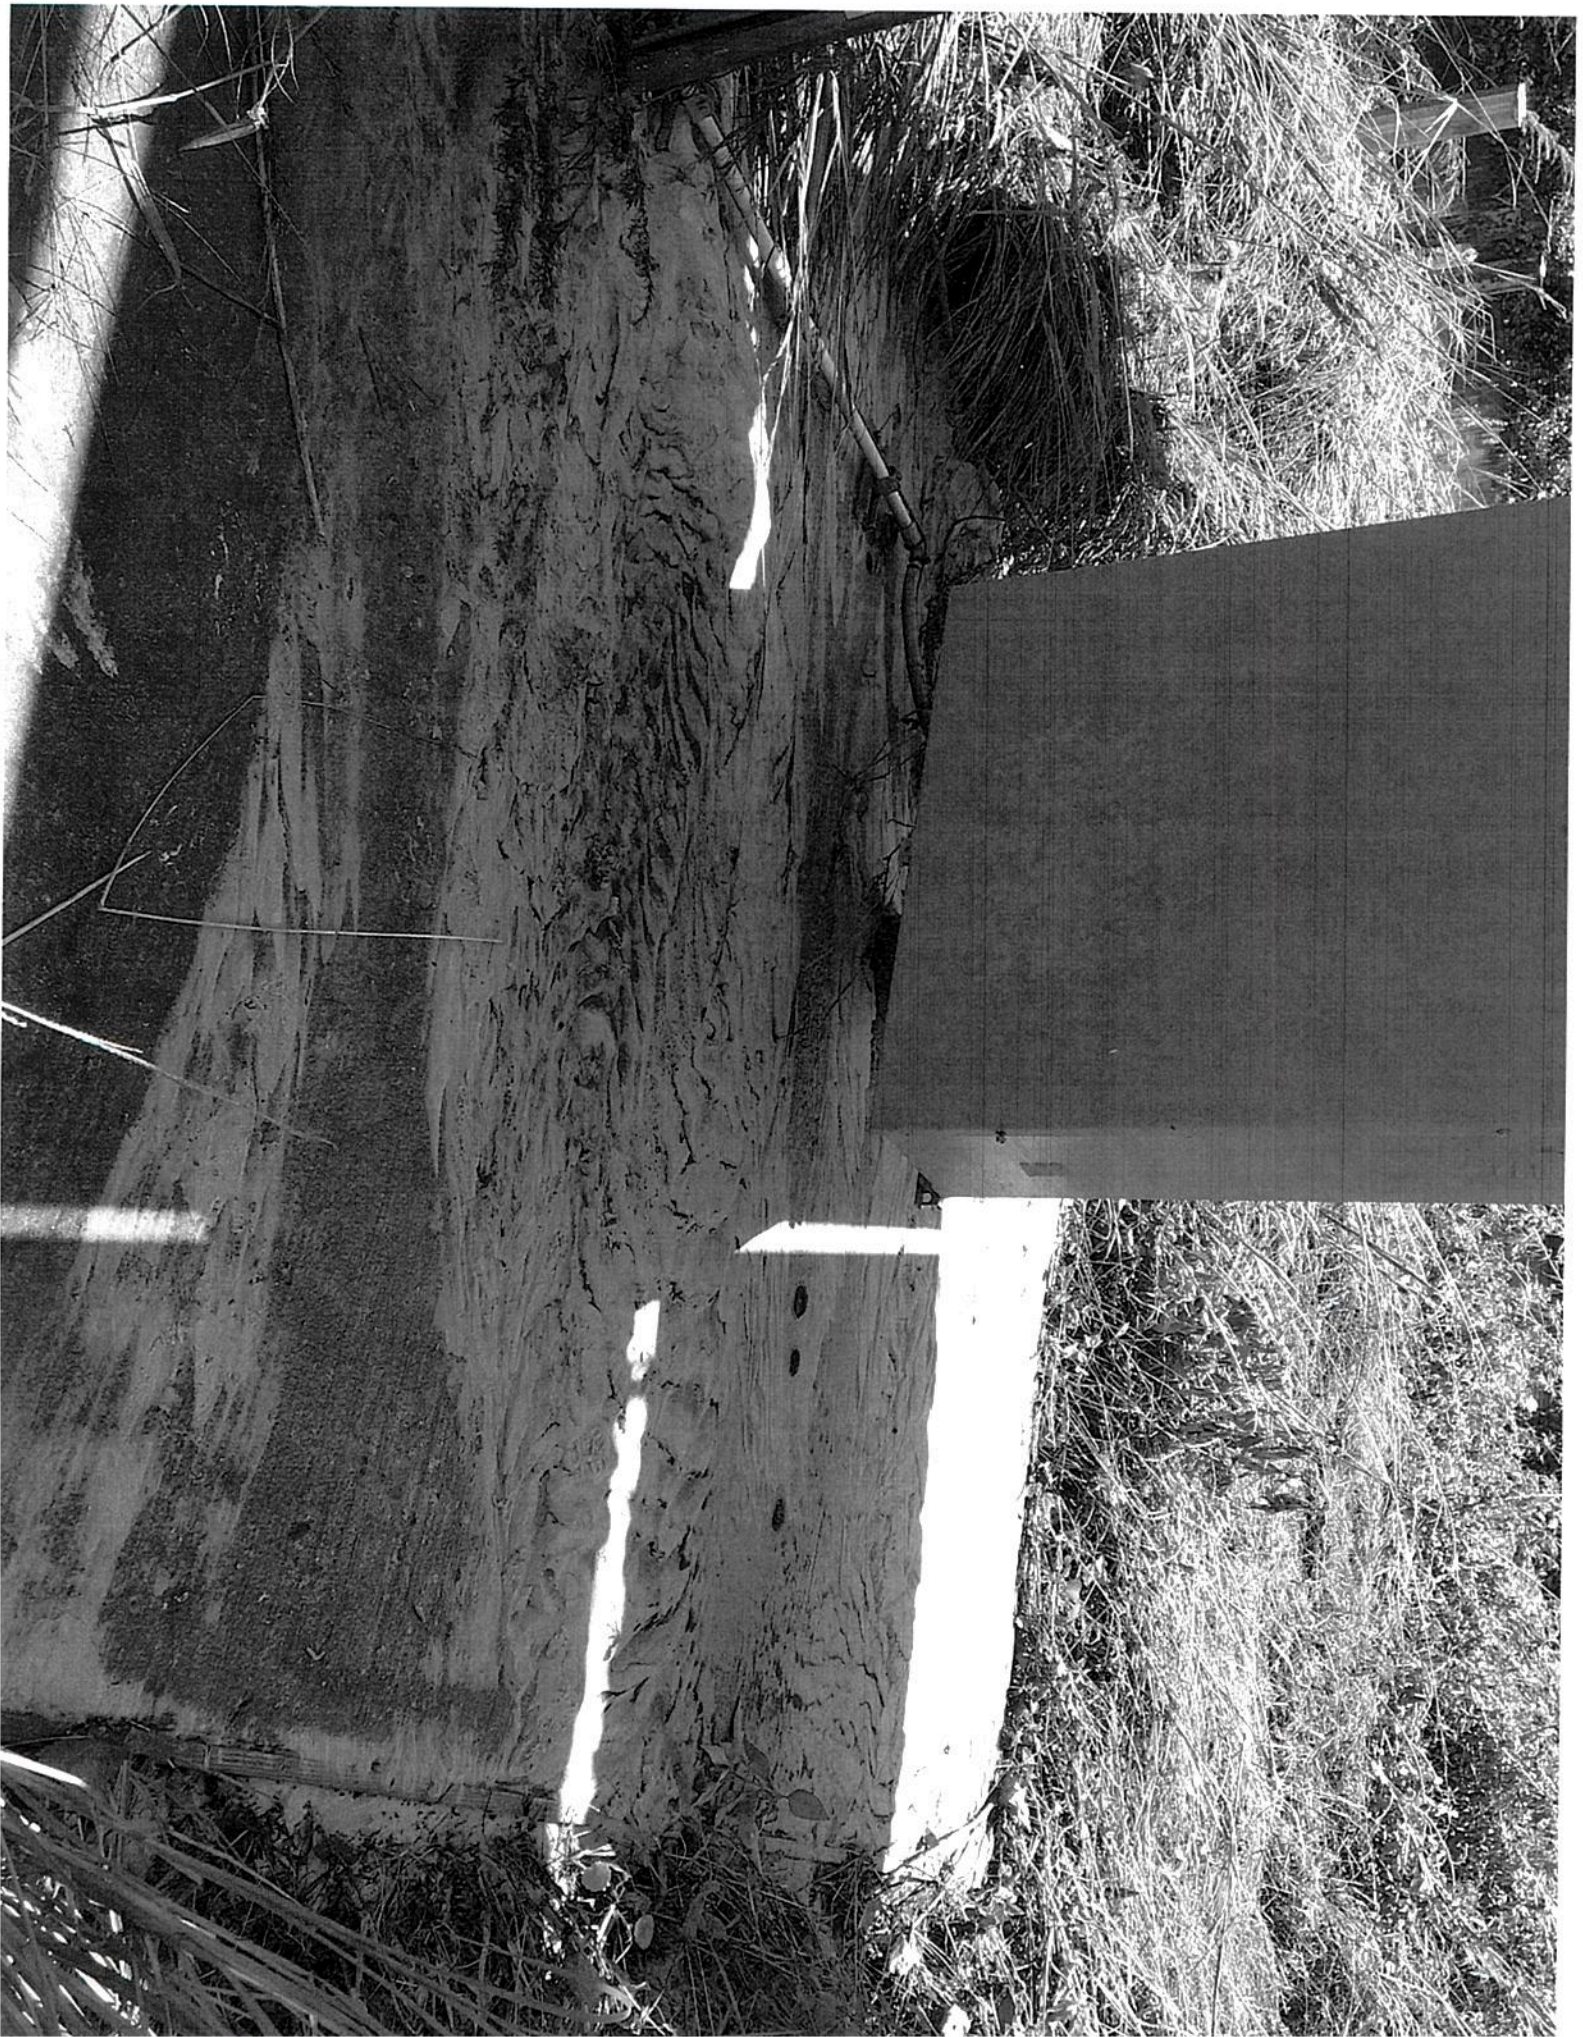
Impacts from Storm: Site generally in good condition. Substantial flooding of air sparging area. But flood water receded.

- **Damaged Equipment: fencing, gates, pumps, piping, etc.:** Air sparging unit B not operational (defective air compressor due to flooding). Mr. Bailey stated that he will report the situation to his manager and equipment will be repaired or replaced as soon as possible.
- **Floodwaters:** Severe flooding observed
- **Cover integrity; Cap scouring, erosion:** Substantial scouring/erosion observed from dredged spoils pile near the creek
- **Monitor well integrity: flooded; missing caps; concrete pads:** Permanent monitoring wells located near air sparging units were flooded but are in good condition. However, some temporary monitoring points along the creek adjacent to air sparging area appeared to be damaged.

Recommendation for follow up Action: RPM to follow-up to ensure air sparging unit B is repaired and temporary monitoring points are repaired or reinstalled. Contractor's crew was onsite to perform annual groundwater monitoring sampling.

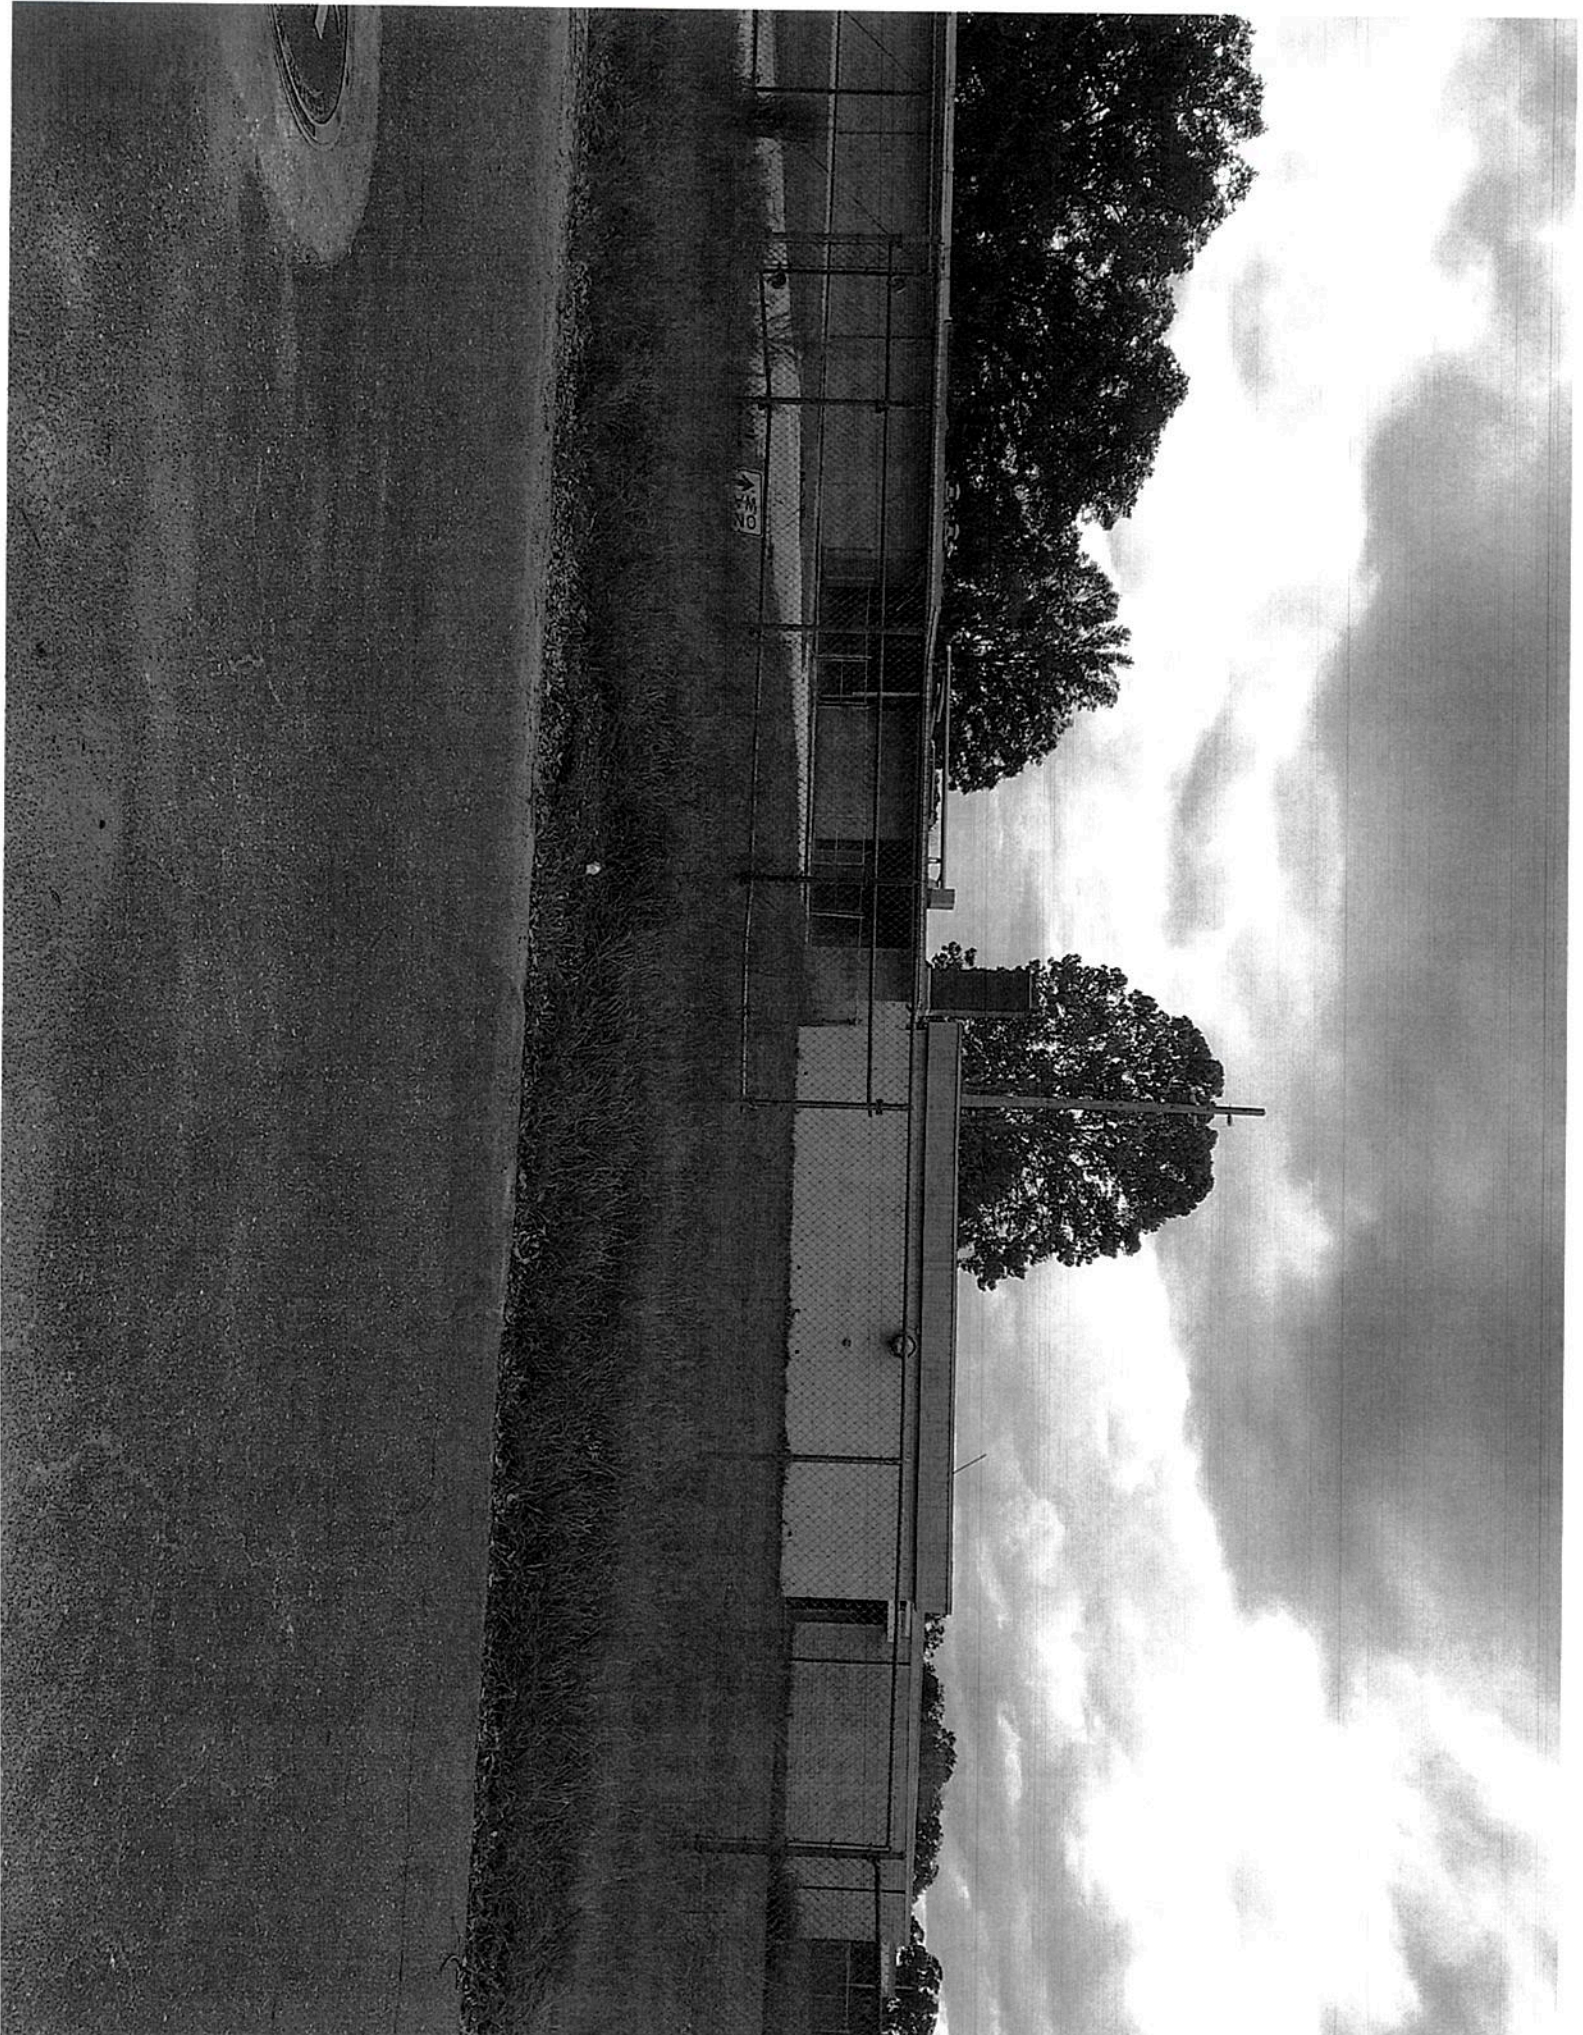
Site Condition: Saturated grounds and falling trees

Additional Comments: Site consists of numerous properties (primarily residential) throughout the City of Jacksonville. Inspection team drove around the area and noticed falling trees and saturated grounds. Some properties were substantially flooded. Wet and damaged household items and furniture were observed on the curb.

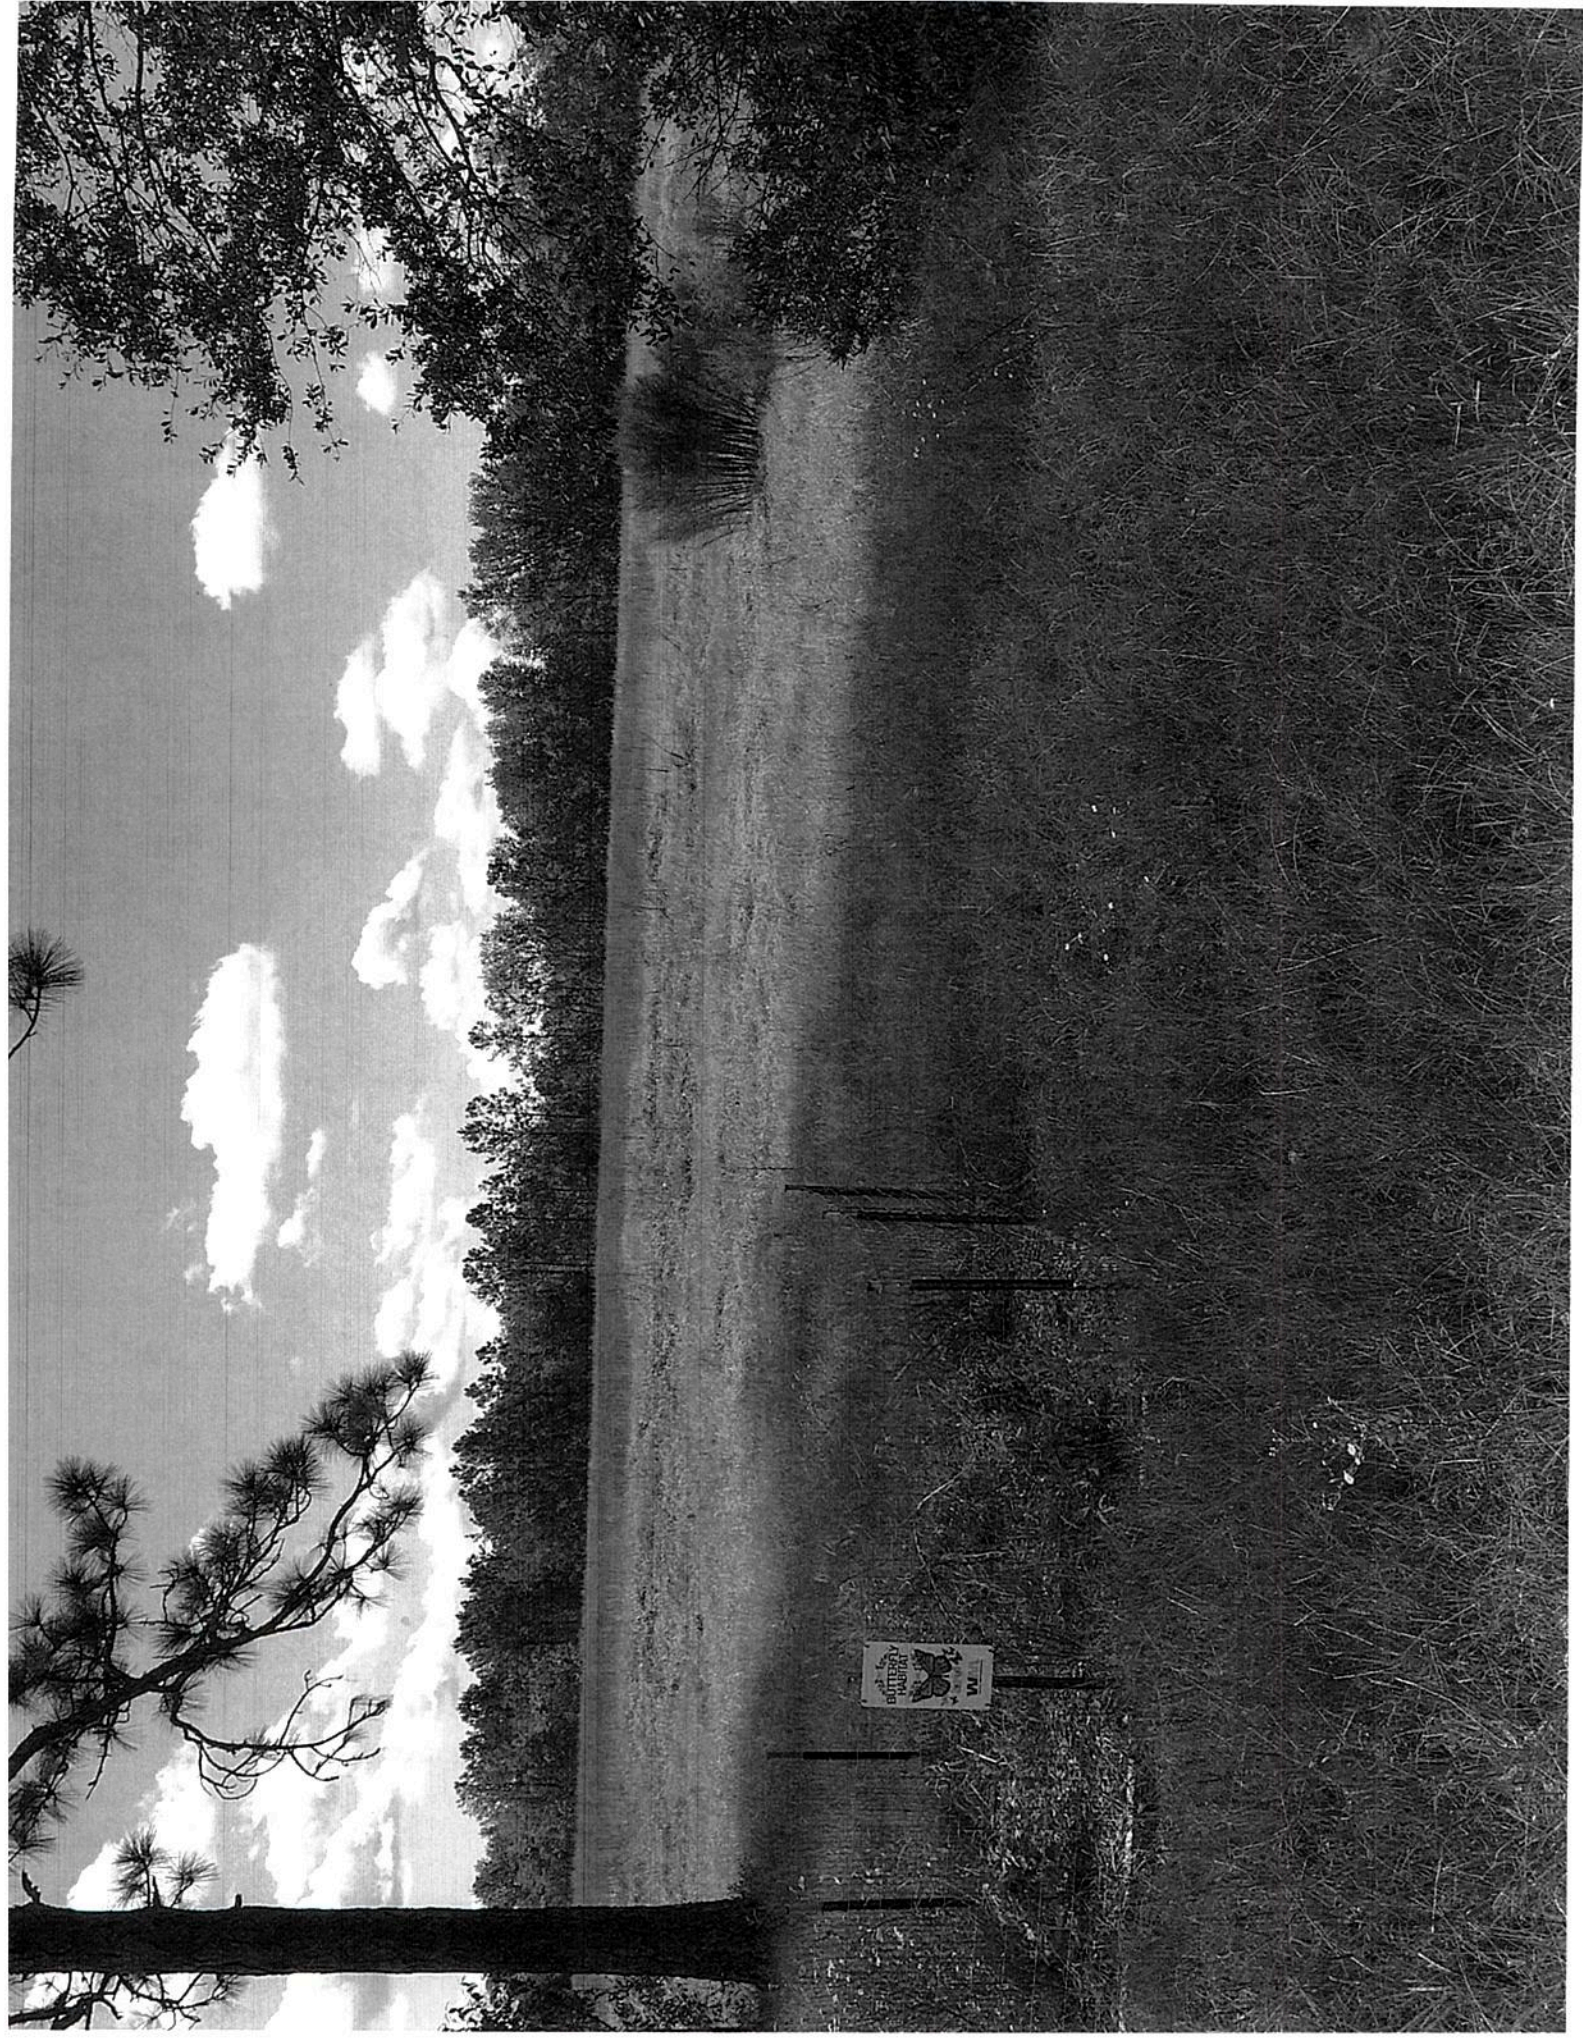
Site Condition: Substantial flooding; falling limbs/branches; Overgrown along fence on Exime Road

- **Damaged Equipment: fencing, gates, pumps, piping, etc:** Falling limbs/branches on fence at intersection of Hipps Rd and Jim Terry Rd.
- **Floodwaters:** Substantial water along Exime Road
- **Cover integrity: Cap scouring, erosion:** Cap in good condition
- Monitor well integrity: flooded; missing caps; concrete pads,

Recommendation for follow up Action: No immediate action required. Falling tree limbs/branches removal in the future.

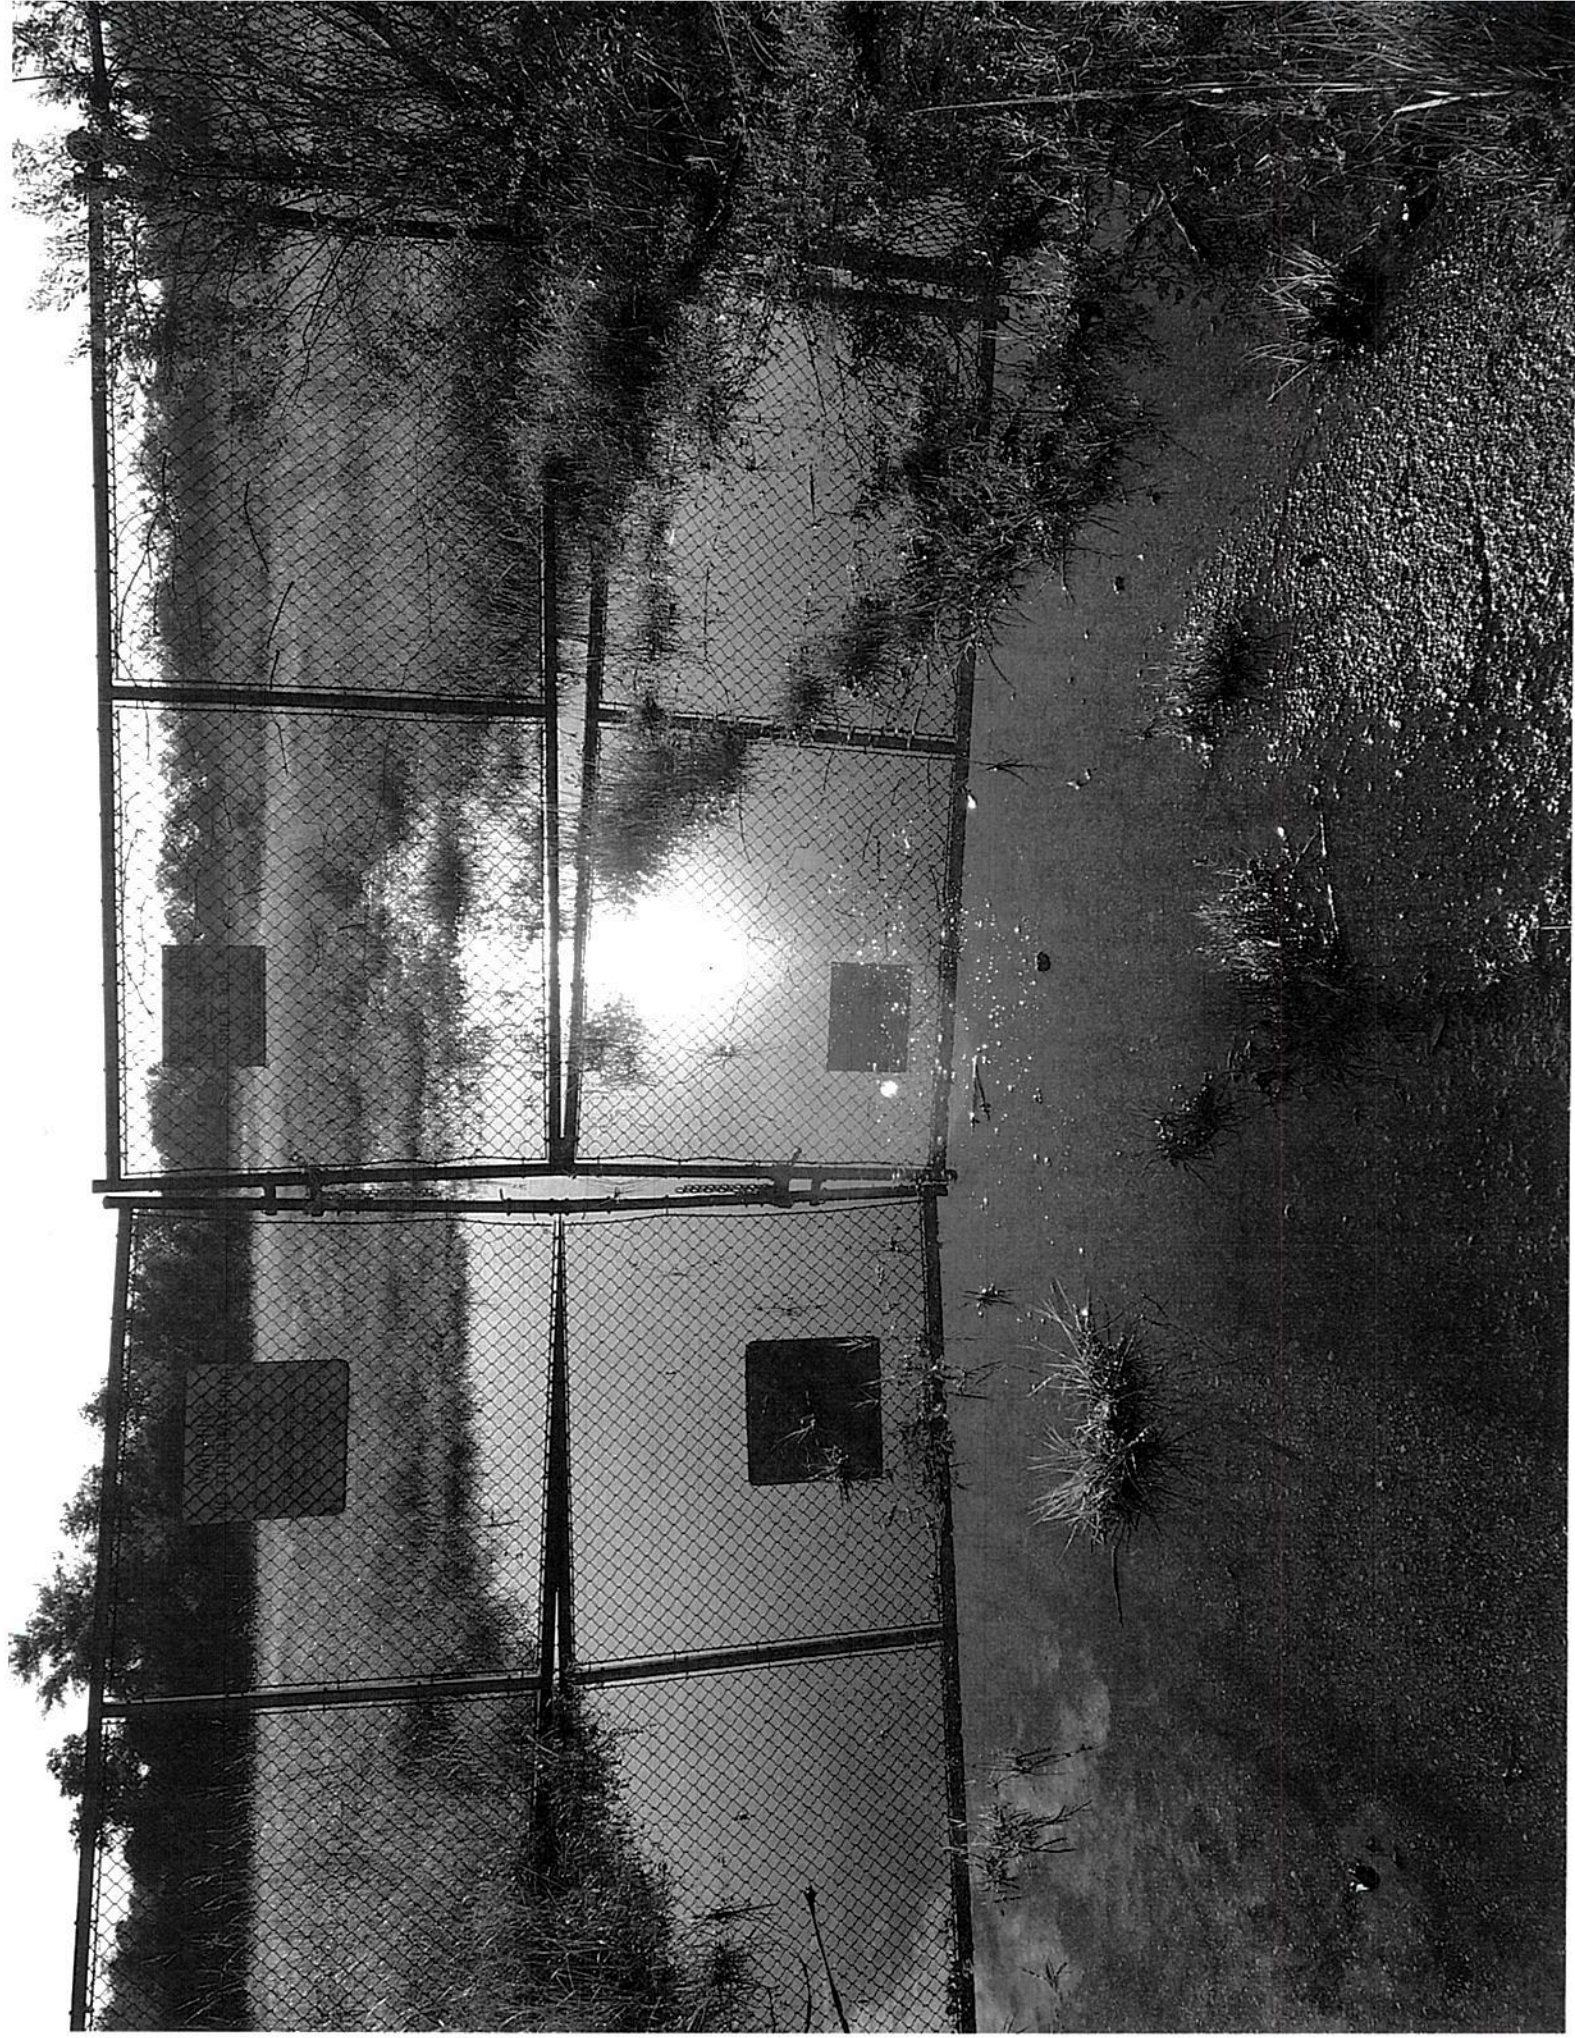
Site Condition: Site in good condition. Saturated grounds (standing water observed from front gate area along Talleyrand Ave). Debris and sediment observed along Talleyrand Ave sidewalk curb.

- **Damaged Equipment: fencing, gates, pumps, piping, etc:** - None
- **Floodwaters:** Site flooded during storm. Saturated grounds. Standing water (2 to 3 inches) by entrance gate (along Talleyrand Ave); Vegetation debris along Talleyrand Ave right-of-way.
- **Cover integrity: Cap scouring, erosion:** Property covered with dense vegetation. Debris and sediment observed along Talleyrand Ave.
- **Monitor well integrity: flooded; missing caps; concrete pads:** None observed from front gate area.

The Kerr-McGee Jacksonville site was inspected by EPA and the Multistate Trust on Wednesday, September 13th. No significant issues related to hurricane Irma were discovered. The ground/soil was saturated and standing water was observed from the entrance gate area. Storm related debris was observed along Talleyrand Avenue, and fallen tree limbs/branches from the property were observed on the southeast corner of Toyota's security fence. The Multistate Trust, the owner of the property, will remove the debris, the downed trees and fix the security fence, if necessary.
